**Flood Control Project Maintenance
Levee Inspections**

Fall 2019 Levee Maintenance Deficiency Summary Report

San Joaquin River Basin

Reclamation District No. 0404 Boggs

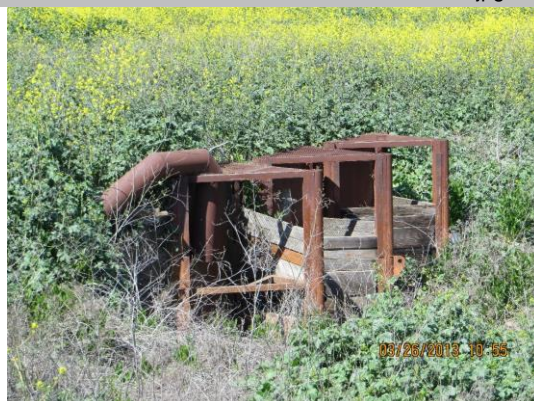
Photo 1 of 3 : UCIP_FA_2019_51168_20041.jpg

LM Start	0.65	Rating **	M	Issue No.	103
LM End	0.65	Issue Type +	En	Location *	
Category	Supplemental			GPS Latitude/Longitude	
				Start	End
Item	DRAFT DWR UCIP Field Study			37.938670 °	37.938670 °
				-121.335397 °	-121.335397 °
DWR ID	17952				
Comment Code					
Inspector Comment					
DS_ID:17952 FS_ID:51168 EP_NO: N/A Repair Type: Non-Urgent Crossing Status: Found UCIP Comments: Steel intake structure on landside of the levee. FIELD_STRUCT_DESC: 1 of 3: 30-inch corrugated metal gravity drainage pipe through the levee, 22 feet below the crown. Flap gate on the waterside (WS) end. Steel intake structure on the landside (LS). [Additional Reference(s): DWR Levee Log, 2006]. FS Date: 3/26/2013

LS- intake structure

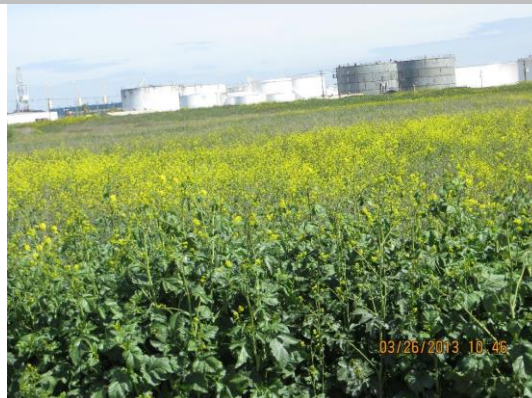
Photo 2 of 3 : UCIP_FA_2019_51168_20040.jpg

LM Start	0.65	Rating **	M	Issue No.	103 (cont)
LM End	0.65	Issue Type +	En	Location *	
Category	Supplemental			GPS Latitude/Longitude	
				Start	End
Item	DRAFT DWR UCIP Field Study			37.938670 °	37.938670 °
				-121.335397 °	-121.335397 °
DWR ID	17952				
Comment Code					
Inspector Comment					
DS_ID:17952 FS_ID:51168 EP_NO: N/A Repair Type: Non-Urgent Crossing Status: Found UCIP Comments: Steel intake structure on landside of the levee. FIELD_STRUCT_DESC: 1 of 3: 30-inch corrugated metal gravity drainage pipe through the levee, 22 feet below the crown. Flap gate on the waterside (WS) end. Steel intake structure on the landside (LS). [Additional Reference(s): DWR Levee Log, 2006]. FS Date: 3/26/2013

LS- overview of land side of the levee.

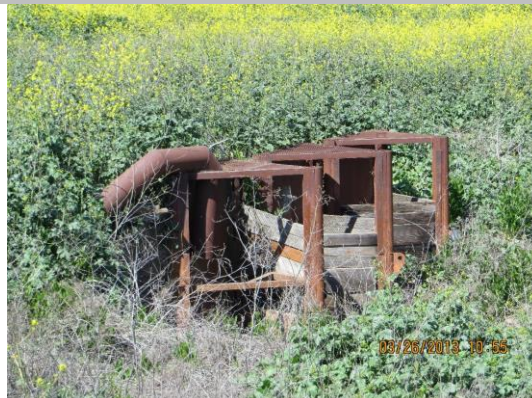
Photo 1 of 3 : UCIP_FA_2019_53348_20047.jpg

Comment Code					
Inspector Comment					
DS_ID:18811 FS_ID:53348 EP_NO: N/A Repair Type: Non-Urgent Crossing Status: Found UCIP Comments: 10/2/2018 The wide levee crown shows no sign of integrity issues; downgrading to Non-Urgent (D. Sanoski - DWR UCIP).12/13/2016 Since previous inspector and 2006 Levee Log cite damage to flap gate, I have upgraded this crossing from Non-Urgent to Urgent. Flap gates need to be in good working condition. (K. Fazel - UCIP)03/26/2013 Steel intake structure on LS. (P. Amatya - DWR)12/26/2006 Landward end filled with dirt. Middle flap gate missing and right flap gate broken as of 1/24/07. (DWR Levee Log) FIELD_STRUCT_DESC: 2 of 3: 30-inch corrugated metal gravity drainage pipe through the levee, 22 feet below the crown. Flap gate on the waterside (WS) end. Steel intake structure on the landside (LS). [Additional Reference(s): DWR Levee Log, 2006]. FS Date: 10/2/2018 12:51:00 PM

LS- steel intake structure

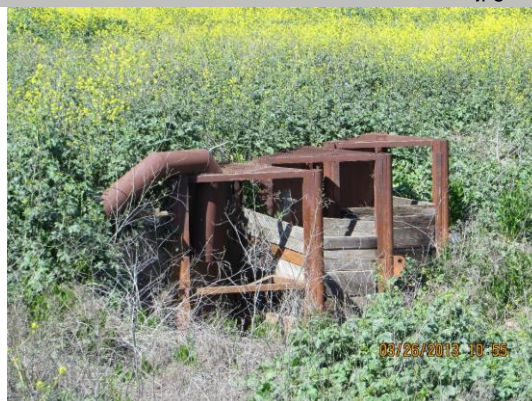
Photo 1 of 3 : UCIP_FA_2019_53349_20054.jpg

Comment Code					
Inspector Comment					
DS_ID:18810 FS_ID:53349 EP_NO: N/A Repair Type: Non-Urgent Crossing Status: Found UCIP Comments: 10/2/2018 The wide levee crown shows no sign of integrity issues; downgrading to Non-Urgent (D. Sanoski - DWR UCIP).12/13/2016 Since previous inspector and 2006 Levee Log cite damage to flap gate, I have upgraded this crossing from Non-Urgent to Urgent. Flap gates need to be in good working condition. (K. Fazel - UCIP)03/26/2013 Steel intake structure on LS. (P. Amatya - DWR)12/26/2006 Landward end filled with dirt. Middle flap gate missing and right flap gate broken as of 1/24/07. (DWR Levee Log) FIELD_STRUCT_DESC: 3 of 3: 30-inch corrugated metal gravity drainage pipe through the levee, 22 feet below the crown. Flap gate on the waterside (WS) end. Steel intake structure on the landside (LS). [Additional Reference(s): DWR Levee Log, 2006]. FS Date: 10/2/2018 12:33:00 PM

LS- steel intake structure

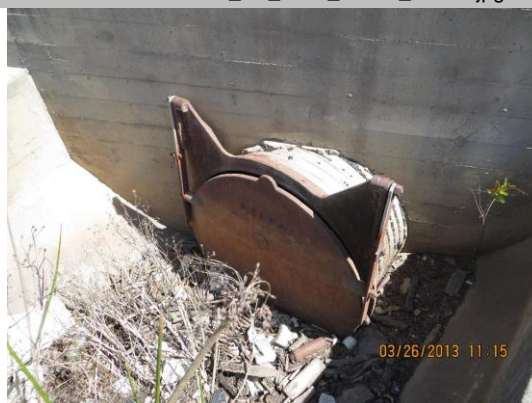
Photo 2 of 3 : UCIP_FA_2019_53532_19962.jpg

Comment Code						
Inspector Comment						
DS_ID:17945 FS_ID:53532 EP_NO: N/A Repair Type: No Action Needed Crossing Status: Found UCIP Comments: 11/22/2017 Received updated photo from DWR levee inspector D. Torres showing gate has been cleared of sediment to allow operation of the gate on the WS. Crossing has been downgraded from Urgent to No Action Needed based on the 2016 photos and the most current photo. Recommend coordinating with City of Stockton to determine as-builts, CVFPB permit, and date of last internal integrity inspection completed for this crossing. (DWR UCIP - O. Magana) 11/29/2016 Flap gate still buried with sediment on WS. Requires clearing. (K. Fazel - UCIP)03/26/2013 Partially buried flap gate (P. Amatya - DWR) FIELD_STRUCT_DESC: 42-inch corrugated metal drainage discharge pipe, 18 feet below the crown. Flap gate, concrete headwall, and spillway on the waterside (WS). Pump house on the landside (LS). Abandoned concrete headwall, power pole, and two wooden piles found on the LS. This drainage pipe likely belongs to the City of Stockton. [Additional Reference(s): DWR Levee Log, 2006. USACE San Joaquin O&M Manual 1, March 1963, (HLM 0.78)]. FS Date: 11/22/2017

WS- drainage outlet structure and CM pipe with flapgate

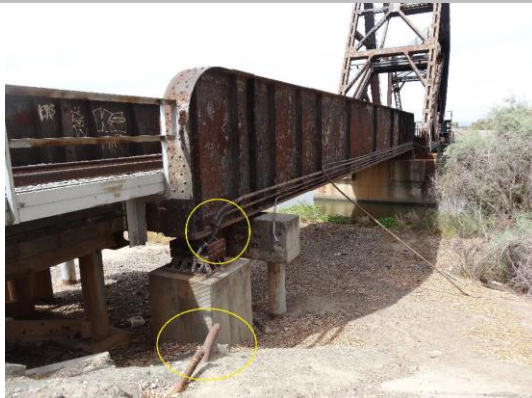
Photo 2 of 3 : UCIP_FA_2019_46810_74754.jpg

LM Start	0.79	Rating **	M	Issue No.	107
LM End	0.79	Issue Type +	En	Location *	
Category	Supplemental			GPS Latitude/Longitude	
				Start	End
Item	DRAFT DWR UCIP Field Study			37.937212°	37.937212°
				-121.333762°	-121.333762°
DWR ID	17946				
Comment Code					
Inspector Comment					
DS_ID:17946 FS_ID:46810 EP_NO: N/A Repair Type: Non-Urgent Crossing Status: Found UCIP Comments: Appears abandoned; if so should be done so properly. FIELD_STRUCT_DESC: Telephone conduit of an unknown size or material through both levees and under the San Joaquin River, at an unknown depth. This buried telephone cable is no longer operational. [Additional Reference(s): DWR Levee Log, 2006]. FS Date: 8/4/2015

WS view looking west: conduits thru levee and attached to bridge

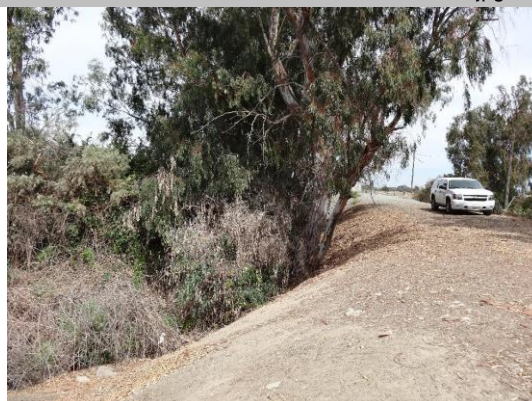
Photo 3 of 3 : UCIP_FA_2019_46810_74755.jpg

LM Start	0.79	Rating **	M	Issue No.	107 (cont)	
LM End	0.79	Issue Type +	En	Location *		
Category	Supplemental			GPS Latitude/Longitude		
				Start	End	
Item	DRAFT DWR UCIP Field Study			37.937212°	37.937212°	
				-121.333762°	-121.333762°	
DWR ID	17946					
Comment Code						
Inspector Comment						
DS_ID:17946 FS_ID:46810 EP_NO: N/A Repair Type: Non-Urgent Crossing Status: Found UCIP Comments: Appears abandoned; if so should be done so properly. FIELD_STRUCT_DESC: Telephone conduit of an unknown size or material through both levees and under the San Joaquin River, at an unknown depth. This buried telephone cable is no longer operational. [Additional Reference(s): DWR Levee Log, 2006]. FS Date: 8/4/2015

WS view at crossing looking north

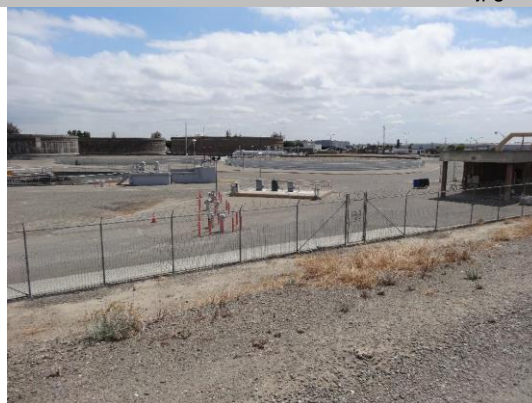
Photo 1 of 3 : UCIP_FA_2019_46801_74745.jpg

Comment Code						
Inspector Comment						
DS_ID:25128 FS_ID:46801 EP_NO: 1164 Repair Type: Non-Urgent Crossing Status: Indicator Found UCIP Comments: Conversation with WWTP engineer Ali Gharegozloo suggested this pipe has been welded shut. If so, mode of abandonment needs verification. FIELD_STRUCT_DESC: 60-inch lock joint reinforced concrete sewage effluent pipe under the levee, 27 feet below the crown. Reinforced concrete apron and cutoff walls. Steel sheet piling apron installed with the pipe on the waterside (WS) slope. Headwall, stairs, and pump with shutoff valve visible on the WS slope. Apparent shutoff valves 30 feet off the landside (LS) toe in alignment with the pipe. (Plans for the construction of a 60-inch lock joint reinforced concrete sewage effluent pipe under the easterly levee of the San Joaquin River authorized under Permit No. 1164, 1947 - City of Stockton). FS Date: 7/9/2015

LS view: apparent shut off valves on WWTP property in alignment with 60-inch pipe.

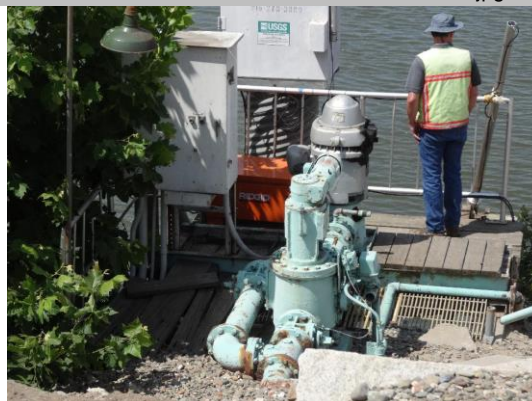
Photo 3 of 3 : UCIP_FA_2019_46801_74748.jpg

Comment Code						
Inspector Comment						
DS_ID:25128 FS_ID:46801 EP_NO: 1164 Repair Type: Non-Urgent Crossing Status: Indicator Found UCIP Comments: Conversation with WWTP engineer Ali Gharegozloo suggested this pipe has been welded shut. If so, mode of abandonment needs verification. FIELD_STRUCT_DESC: 60-inch lock joint reinforced concrete sewage effluent pipe under the levee, 27 feet below the crown. Reinforced concrete apron and cutoff walls. Steel sheet piling apron installed with the pipe on the waterside (WS) slope. Headwall, stairs, and pump with shutoff valve visible on the WS slope. Apparent shutoff valves 30 feet off the landside (LS) toe in alignment with the pipe. (Plans for the construction of a 60-inch lock joint reinforced concrete sewage effluent pipe under the easterly levee of the San Joaquin River authorized under Permit No. 1164, 1947 - City of Stockton). FS Date: 7/9/2015

WS view: closeup of pump. CMP riser for USGS gage behind pump.

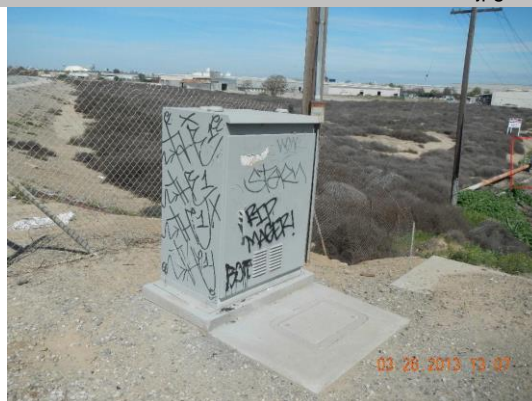
Photo 1 of 3 : UCIP_FA_2019_50763_20104.jpg

Comment Code						
Inspector Comment						
DS_ID:18708 FS_ID:50763 EP_NO: 4175 Repair Type: Non-Urgent Crossing Status: Found UCIP Comments: 11/17/2016 FPIIB Inspector Richard Willoughby noted 3-4 inch depression over pipes on crown, an indication of possible pipe collapse. (K. Fazel - UCIP) FIELD_STRUCT_DESC: 1 of 2: 12-inch steel drainage discharge pipe through the levee, 5 feet below the crown. Siphon breaker on the waterside (WS) shoulder. Power pole, electrical control panel, and pump about 200 feet off the landside (LS) toe. (Plans for installation of a 10-inch, 12-gauge welded steel discharge pipe over the levee authorized under Permit No. 4175, 1963 - City of Stockton). [Additional Reference(s): DWR Levee Log, 2006]. FS Date: 11/17/2016

LS- overview of pipe and pump (far right)

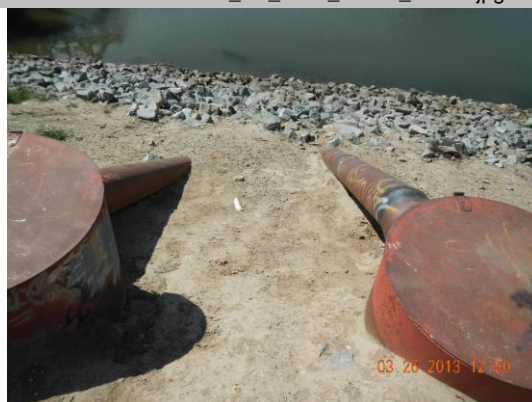
Photo 2 of 3 : UCIP_FA_2019_50763_20103.jpg

WS- steel pipes and siphon breakers in steel pipe risers.

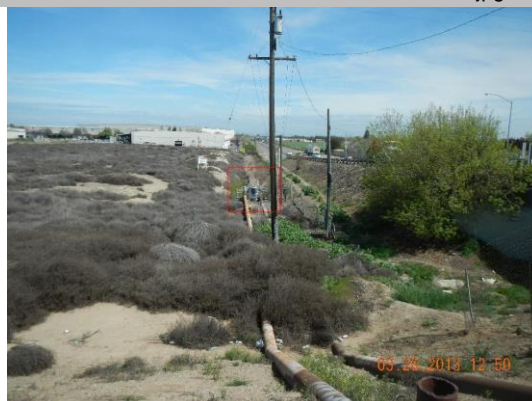
Photo 3 of 3 : UCIP_FA_2019_50763_20102.jpg

Comment Code						
Inspector Comment						
DS_ID:18708 FS_ID:50763 EP_NO: 4175 Repair Type: Non-Urgent Crossing Status: Found UCIP Comments: 11/17/2016 FPIIB Inspector Richard Willoughby noted 3-4 inch depression over pipes on crown, an indication of possible pipe collapse. (K. Fazel - UCIP) FIELD_STRUCT_DESC: 1 of 2: 12-inch steel drainage discharge pipe through the levee, 5 feet below the crown. Siphon breaker on the waterside (WS) shoulder. Power pole, electrical control panel, and pump about 200 feet off the landside (LS) toe. (Plans for installation of a 10-inch, 12-gauge welded steel discharge pipe over the levee authorized under Permit No. 4175, 1963 - City of Stockton). [Additional Reference(s): DWR Levee Log, 2006]. FS Date: 11/17/2016

LS- pipes and pumps (center)

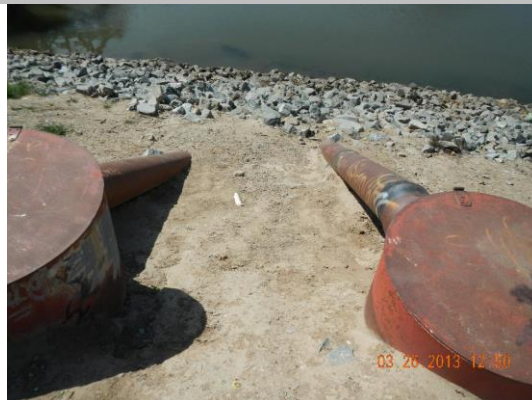
Photo 1 of 3 : UCIP_FA_2019_50764_19994.jpg

DS_ID:17955
 FS_ID:50764
 EP_NO: 4175
 Repair Type: Non-Urgent
 Crossing Status: Found
 UCIP Comments: 11/17/2016 FPIIB Inspector Richard Willoughby noted 3-4 inch dip in crown over pipes, an indication of possible pipe collapse. (K. Fazel - UCIP)
 FIELD_STRUCT_DESC: 2 of 2: 12-inch steel drainage discharge pipe through the levee, 5 feet below the crown. Siphon breaker on the waterside (WS) shoulder. Power pole, electrical control panel, and pump about 200 feet off the landside (LS) toe. (Plans for installation of a 10-inch, 12-gauge welded steel discharge pipe over the levee authorized under Permit No. 4175, 1963 - City of Stockton). [Additional Reference(s): DWR Levee Log, 2006, 10-inch pipe referenced].
 FS Date: 11/17/2016

WS- steel pipes and siphon breakers in steel pipe risers.

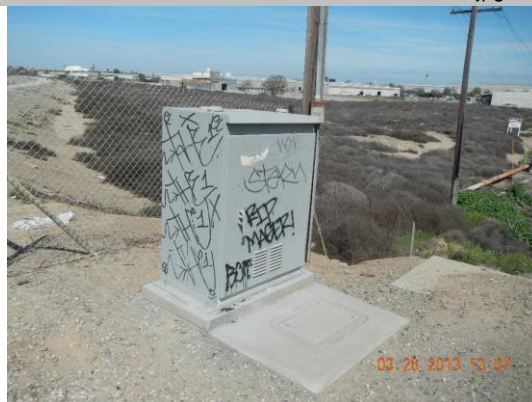
Photo 2 of 3 : UCIP_FA_2019_50764_19996.jpg

LS- pipe and pump on far left.

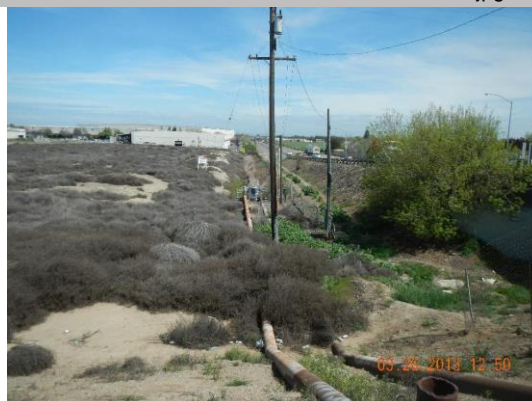
Photo 3 of 3 : UCIP_FA_2019_50764_19995.jpg

Comment Code						
Inspector Comment						
DS_ID:17955 FS_ID:50764 EP_NO: 4175 Repair Type: Non-Urgent Crossing Status: Found UCIP Comments: 11/17/2016 FPIIB Inspector Richard Willoughby noted 3-4 inch dip in crown over pipes, an indication of possible pipe collapse. (K. Fazel - UCIP) FIELD_STRUCT_DESC: 2 of 2: 12-inch steel drainage discharge pipe through the levee, 5 feet below the crown. Siphon breaker on the waterside (WS) shoulder. Power pole, electrical control panel, and pump about 200 feet off the landside (LS) toe. (Plans for installation of a 10-inch, 12-gauge welded steel discharge pipe over the levee authorized under Permit No. 4175, 1963 - City of Stockton). [Additional Reference(s): DWR Levee Log, 2006, 10-inch pipe referenced]. FS Date: 11/17/2016

LS- pipes and pumps on center.

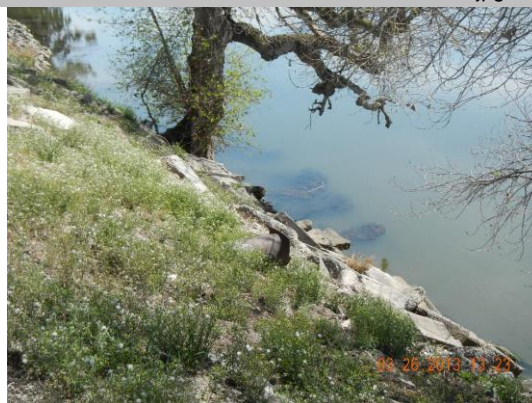
Photo 1 of 3 : UCIP_FA_2019_40487_20064.jpg

Comment Code					
Inspector Comment					
DS_ID:18812 FS_ID:40487 EP_NO: 10897 Repair Type: Non-Urgent Crossing Status: Found UCIP Comments: Abandoned crossing. WS pipe capped with steel pipe and LS pipe cut. FIELD_STRUCT_DESC: *ABANDONED* 14-inch irrigation discharge pipe of an unknown material through the levee, 3 feet below the crown. Siphon breaker on the waterside (WS). (Plans to install a 20-horsepower irrigation pump on an existing structure and a 14-inch discharge pipe through the levee authorized under Permit No. 10897, 1975 - Alfred Volpi. 14-inch pipe replaces existing 12-inch pipe). [Additional Reference(s): DWR Levee Log, 2006. USACE San Joaquin O&M Manual 1, March 1963, (HLM 1.63), 12-inch pipe referenced, 5.5 feet below the crown]. FS Date: 3/26/2013

WS- steel pipe capped with steel plate.

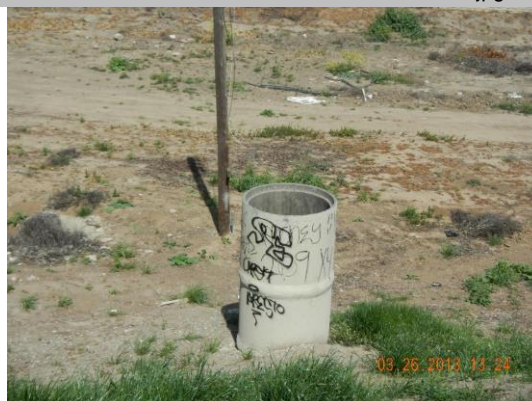
Photo 2 of 3 : UCIP_FA_2019_40487_20063.jpg

Comment Code						
Inspector Comment						
DS_ID:18812 FS_ID:40487 EP_NO: 10897 Repair Type: Non-Urgent Crossing Status: Found UCIP Comments: Abandoned crossing. WS pipe capped with steel pipe and LS pipe cut. FIELD_STRUCT_DESC: *ABANDONED* 14-inch irrigation discharge pipe of an unknown material through the levee, 3 feet below the crown. Siphon breaker on the waterside (WS). (Plans to install a 20-horsepower irrigation pump on an existing structure and a 14-inch discharge pipe through the levee authorized under Permit No. 10897, 1975 - Alfred Volpi. 14-inch pipe replaces existing 12-inch pipe). [Additional Reference(s): DWR Levee Log, 2006. USACE San Joaquin O&M Manual 1, March 1963, (HLM 1.63), 12-inch pipe referenced, 5.5 feet below the crown]. FS Date: 3/26/2013

LS- concrete standpipe on levee slope

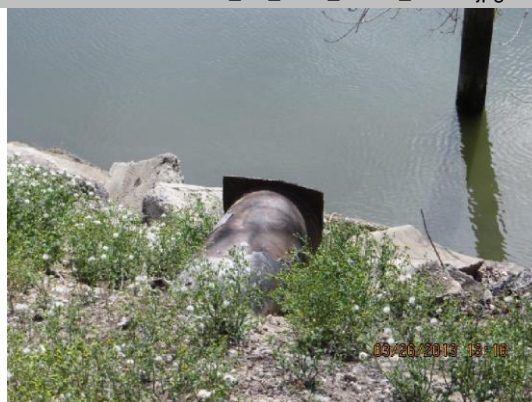
Photo 3 of 3 : UCIP_FA_2019_40487_20065.jpg

WS- abandoned steel pipe capped with steel plate.

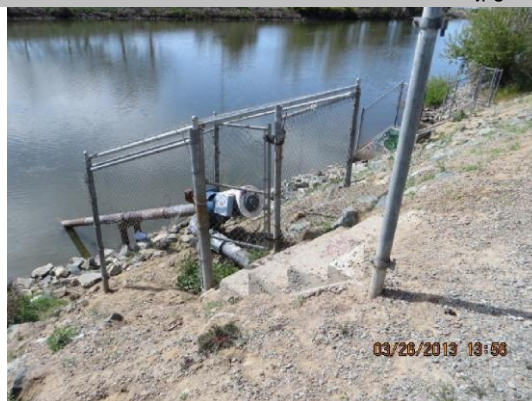
Photo 1 of 3 : UCIP_FA_2019_40797_20073.jpg

Comment Code						
Inspector Comment						
DS_ID:17961 FS_ID:40797 EP_NO: 6560 Repair Type: Non-Urgent Crossing Status: Found UCIP Comments: Damaged siphon breaker in pipe riser near the landward shoulder. FIELD_STRUCT_DESC: 8-inch steel irrigation discharge pipe through the levee, 7 feet below the crown. Chain-link fence around the pump and motor on the waterside (WS) slope. (Plans to install a 7-horsepower pump and motor, cyclone fence, and an 8-inch steel pipe through the levee authorized under Permit No. 6560, 1969 - City of Stockton, Department of Public Works). [Additional Reference(s): DWR Levee Log, 2006]. FS Date: 3/26/2013

WS- slanted pump, pipe, and concrete steps on levee slope.

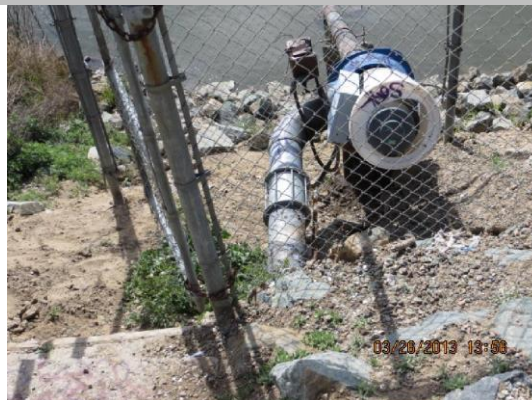
Photo 2 of 3 : UCIP_FA_2019_40797_20072.jpg

WS- slanted pump, and pipe on levee slope.

Comment Code						
Inspector Comment						
DS_ID:17961 FS_ID:40797 EP_NO: 6560 Repair Type: Non-Urgent Crossing Status: Found UCIP Comments: Damaged siphon breaker in pipe riser near the landward shoulder. FIELD_STRUCT_DESC: 8-inch steel irrigation discharge pipe through the levee, 7 feet below the crown. Chain-link fence around the pump and motor on the waterside (WS) slope. (Plans to install a 7-horsepower pump and motor, cyclone fence, and an 8-inch steel pipe through the levee authorized under Permit No. 6560, 1969 - City of Stockton, Department of Public Works). [Additional Reference(s): DWR Levee Log, 2006]. FS Date: 3/26/2013

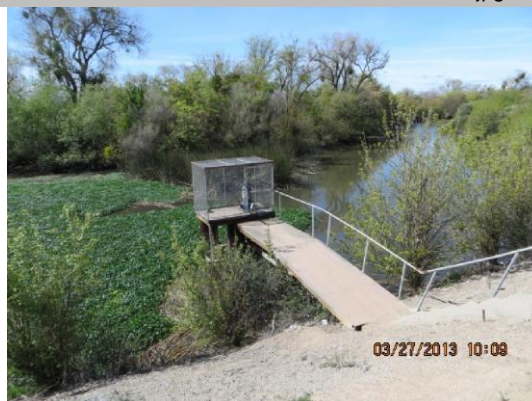
Photo 1 of 3 : UCIP_FA_2019_10908_18182.jpg

Comment Code						
Inspector Comment						
DS_ID:18781 FS_ID:10908 EP_NO: 3340A Repair Type: Non-Urgent Crossing Status: Found UCIP Comments: - Not working for 5 years- Golf club staff- Wooden Walkway; Concrete steps- Damaged siphon breaker FIELD_STRUCT_DESC: 6-inch steel irrigation discharge pipe through the levee, 2 feet below the crown. One corrugated metal cutoff wall. Pump on a pile structure in the stream. Shutoff valve and siphon breaker on the waterside (WS) shoulder. Timber walkway on the WS slope. (Plans for installation of three pumping plants on the north levee of French Camp Slough authorized under Permit No. 3340-A, 1960 - City of Stockton). [Additional Reference(s): DWR Levee Log, 2006]. FS Date: 3/27/2013

WS- pump on steel structure and wooden walkway

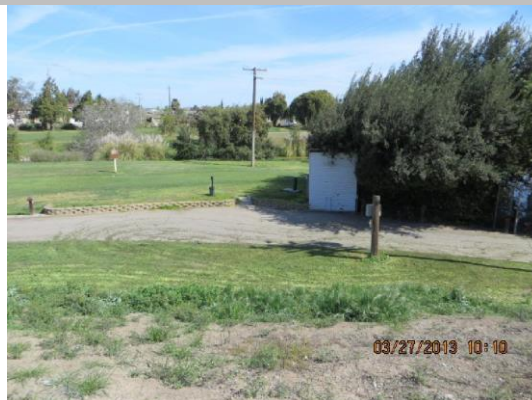
Photo 3 of 3 : UCIP_FA_2019_10908_18180.jpg

LS- overview of LS slope

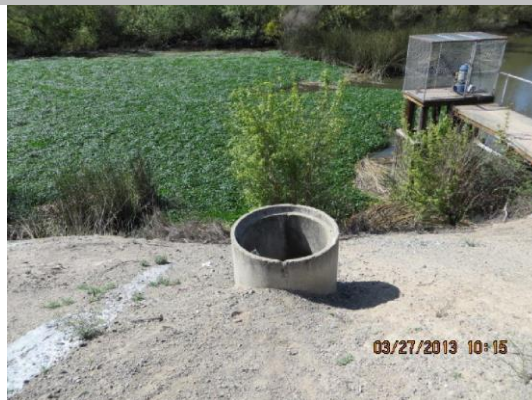
Photo 2 of 3 : UCIP_FA_2019_10945_18247.jpg

WS- concrete riser on steep levee slope

Comment Code						
Inspector Comment						
DS_ID:18782 FS_ID:10945 EP_NO: 4448 Repair Type: Non-Urgent Crossing Status: Found UCIP Comments: Concrete stairway on waterward slope- Not found. Pump was working during field survey. Siphon breaker cap missing. FIELD_STRUCT_DESC: 18-inch steel drainage discharge pipe through the levee, 9.3 feet below the crown. Pump on the landside (LS). Two corrugated metal cutoff walls. Siphon breaker in a concrete well on the waterside (WS) shoulder. (Plans for installation of a discharge pipe through the levee authorized under Permit No. 4448, 1964 - City of Stockton, Department of Public Works). [Additional Reference(s): DWR Levee Log, 2006]. FS Date: 3/27/2013

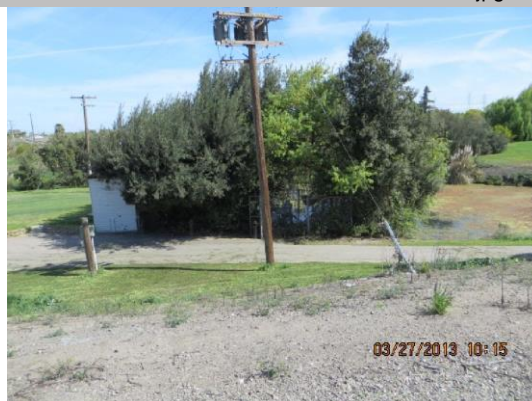
Photo 3 of 3 : UCIP_FA_2019_10945_18250.jpg

LS- overview of pumping plant and levee slope

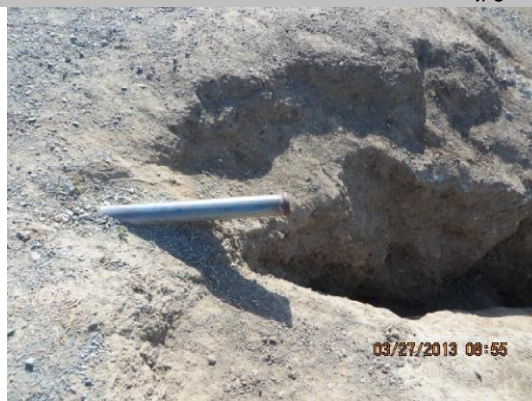
Photo 1 of 3 : UCIP_FA_2019_51171_18134.jpg

WS- capped 3-inch GI pipe

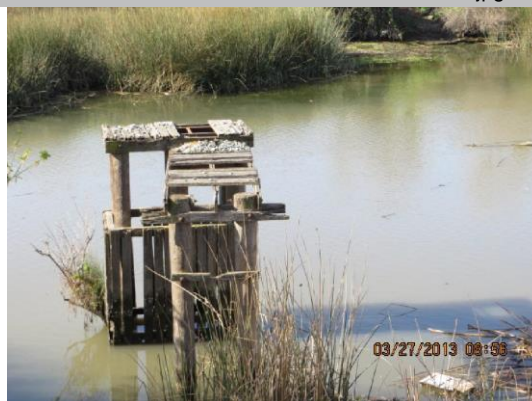
Photo 3 of 3 : UCIP_FA_2019_51171_18132.jpg

WS- abandoned pump station.

Comment Code						
Inspector Comment						
DS_ID:18793						
FS_ID:41904						
EP_NO: 6623						
Repair Type: Non-Urgent						
Crossing Status: Not Found						
UCIP Comments: Need to contact owner to determine status of crossing and install markers if appropriate to do so.						
FIELD_STRUCT_DESC: 5-inch steel natural gas pipeline through the levee and across the channel, 6.4 feet below the crown. One corrugated metal cutoff wall. Waterside (WS) slope rock revetted. Vent pipe at the WS shoulder. (Plans to install a 5-inch steel natural gas pipeline across Walker Slough and across French Camp Slough authorized under Permit No. 6623, 1969 - Laymac Corporation). [Additional Reference(s): DWR Levee Log, 2006].						
FS Date: 3/27/2013

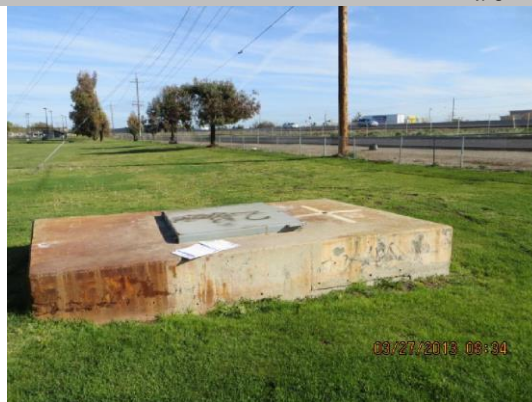
Photo 1 of 3 : UCIP_FA_2019_10846_18127.jpg

LM Start	1.76	Rating **	M	Issue No.	29
LM End	1.76	Issue Type +	En	Location *	
Category	Supplemental			GPS Latitude/Longitude	
				Start	End
Item	DRAFT DWR UCIP Field Study			37.917284 °	37.917284 °
				-121.291740 °	-121.291740 °
DWR ID	18804				
Comment Code					
Inspector Comment					
DS_ID:18804 FS_ID:10846 EP_NO: N/A Repair Type: Non-Urgent Crossing Status: Indicator Found UCIP Comments: Only a 7 ft x 14 ft concrete vault found on LS.Needs a sign post.Bob Winter from KSN(representative of RD 404) will investigate on this crossing. FIELD_STRUCT_DESC: 1 of 2: 42-inch reinforced concrete sewer line through the levee, 8 feet below the crown. Pipe crosses another 42-inch sewer line under the channel. [Additional Reference(s): DWR Levee Log, 2006]. FS Date: 3/27/2013

LS- 7' x 14' concrete vault.

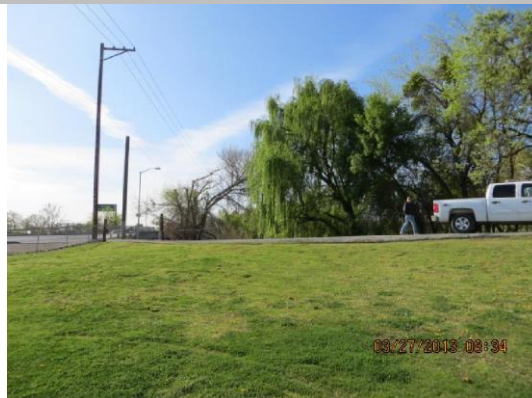
Photo 2 of 3 : UCIP_FA_2019_10846_18126.jpg

Crown view of the levee.

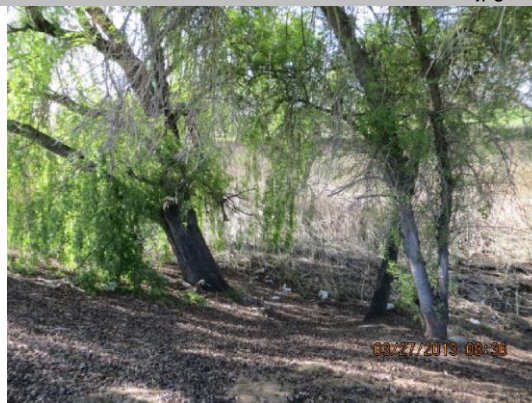
Photo 3 of 3 : UCIP_FA_2019_10846_18128.jpg

WS- no pipes found.

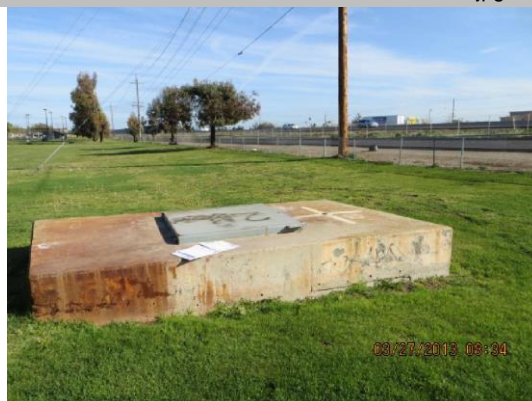
Photo 1 of 3 : UCIP_FA_2019_12426_20130.jpg

LM Start	1.76	Rating **	M	Issue No.	30
LM End	1.76	Issue Type +	En	Location *	
Category	Supplemental			GPS Latitude/Longitude	
				Start	End
Item	DRAFT DWR UCIP Field Study			37.917284 °	37.917284 °
				-121.291740 °	-121.291740 °
DWR ID	18787				
Comment Code					
Inspector Comment					
DS_ID:18787 FS_ID:12426 EP_NO: N/A Repair Type: Non-Urgent Crossing Status: Indicator Found UCIP Comments: Only a 7 ft x 14 ft concrete vault found on LS.Needs a sign post.Bob Winter from KSN(representative of RD 404) will investigate on this crossing. FIELD_STRUCT_DESC: 2 of 2: 42-inch reinforced concrete sewer line through the levee, 8 feet below the crown. Pipe crosses another 42-inch sewer line under the channel. [Additional Reference(s): DWR Levee Log, 2006]. FS Date: 3/27/2013

LS- 7' x 14' concrete vault.

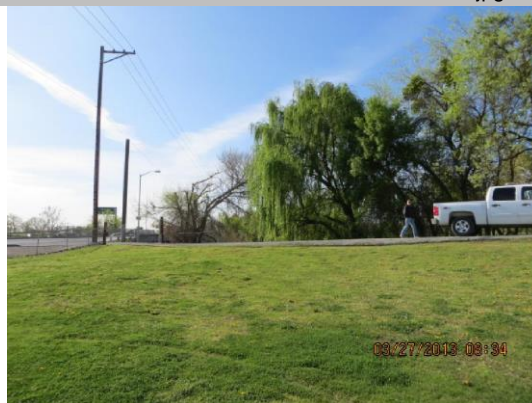
Photo 2 of 3 : UCIP_FA_2019_12426_20129.jpg

Crown view of the levee.

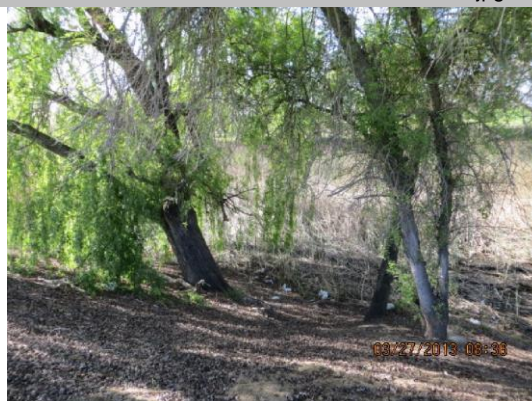
Photo 3 of 3 : UCIP_FA_2019_12426_20131.jpg

LM Start	1.76	Rating **	M	Issue No.	30 (cont)	
LM End	1.76	Issue Type +	En	Location *		
Category	Supplemental			GPS Latitude/Longitude		
				Start	End	
Item	DRAFT DWR UCIP Field Study			37.917284 °	37.917284 °	
				-121.291740 °	-121.291740 °	
DWR ID	18787					
Comment Code						
Inspector Comment						
DS_ID:18787						
FS_ID:12426						
EP_NO: N/A						
Repair Type: Non-Urgent						
Crossing Status: Indicator Found						
UCIP Comments: Only a 7 ft x 14 ft concrete vault found on LS.Needs a sign post.Bob Winter from KSN(representative of RD 404) will investigate on this crossing.						
FIELD_STRUCT_DESC: 2 of 2: 42-inch reinforced concrete sewer line through the levee, 8 feet below the crown. Pipe crosses another 42-inch sewer line under the channel. [Additional Reference(s): DWR Levee Log, 2006].						
FS Date: 3/27/2013

WS- no pipes found.
